Conservation and Management Strategies Applied to Post-Recovery Analysis of the American Civil War Submarine *H. L. Hunley* (1864)

Paul Mardikian

Warren Lasch Conservation Center, *H. L. Hunley* Project, 1250 Supply Street, North Charleston, SC 29405, USA

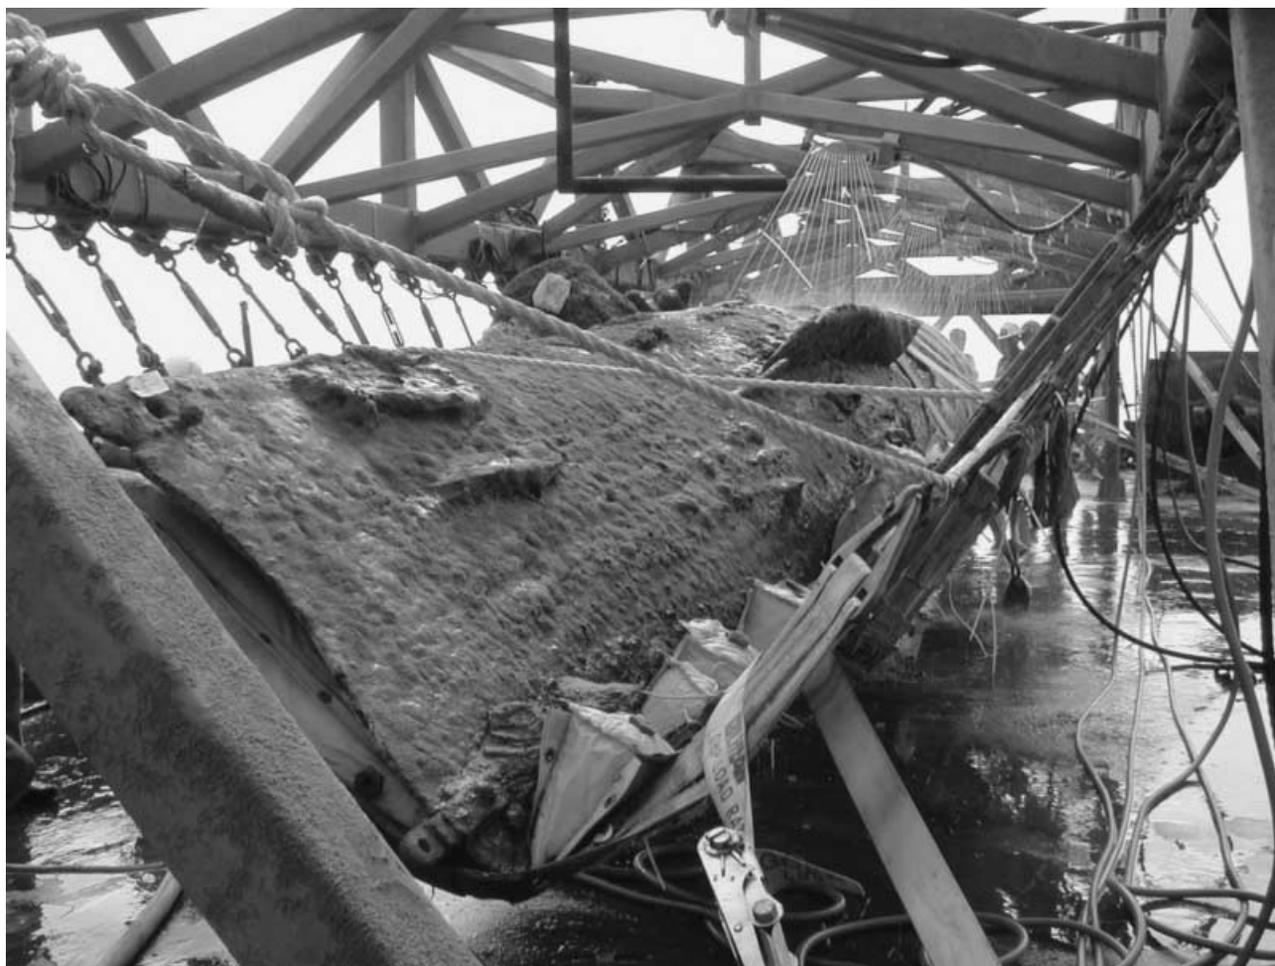
Figure 1. The *H.L. Hunley* on the barge en route to Charleston. Note the 45° angle of the submarine on its starboard side and the spray down system attached to the truss. (Copyright, Friends of the Hunley Inc., 2000)

lifting and transportation operations by Ocean-ering International. Since the concretion covering the hull was apparently intact after the raising, there was no need to use hydraulic cement or other products similar to those used in 1996 and 1999 during underwater surveys of the submarine.² The objective was to make sure that exposure of *Hunley* to the atmosphere would not induce adverse chain reactions. Since the surface of the hull would remain sealed off whether intact or patched, and the amount of time between *Hunley*’s recovery and placement in its tank would be less than eight hours, the decision was made to keep the submarine visible to the public once it was on the recovery barge. However, the submarine was constantly wetted with salt water during its trip back to Charleston so it would not dry out.

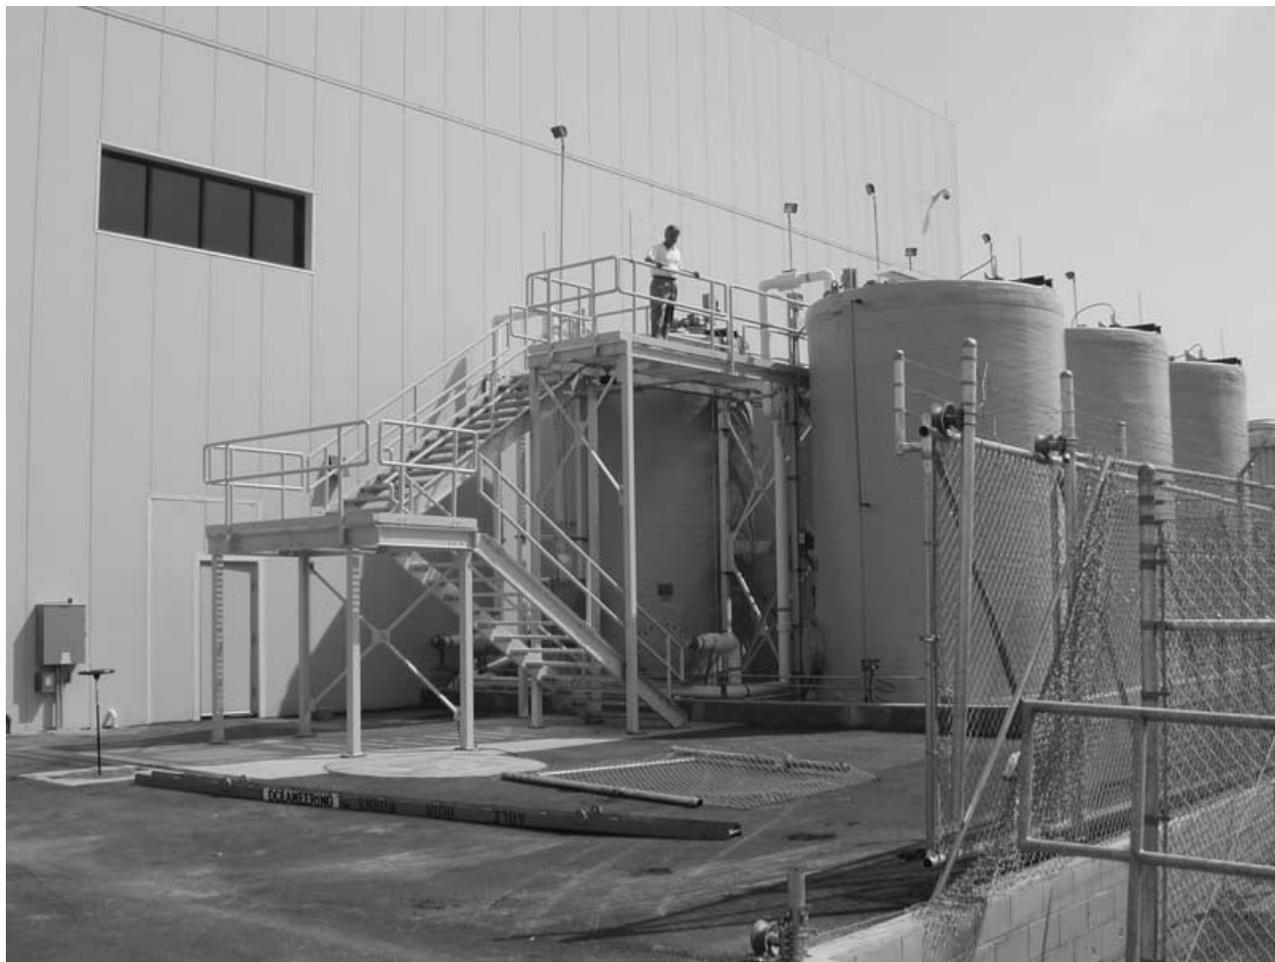
Figure 2. View of the 6 mixing tanks located outside the building. (© Friends of the Hunley Inc., 2000)

Each piece of equipment in the laboratory area had to be tested before the day of the recovery. The 50-ton steel tank was leak-tested, and the time needed to fill or empty the tank recorded (approximately 4 hours for each process). The water (or any chemical mixed with it) would be transferred into six 15,000-gallon, fibreglass-mixing tanks

located outside the building (Fig. 2). These tanks would serve a dual purpose. To provide temporary storage for tank water when the submarine was to be exposed (afterwards, the solution would be pumped back into the storage tank), and as a waste neutralization system if the chemicals used for the treatment had to be tested before discharge in the sewer or neutralized within the discharge limits of the Navy's Pretreatment Discharge Permit (6.5–9.5 pH). Every batch under or above these values would need to be corrected with either sodium hydroxide or nitric acid before the solution could be tested by an independent analytical laboratory and then slowly released into the sewer system at a rate of 95 litres (25 gallons) per minute.

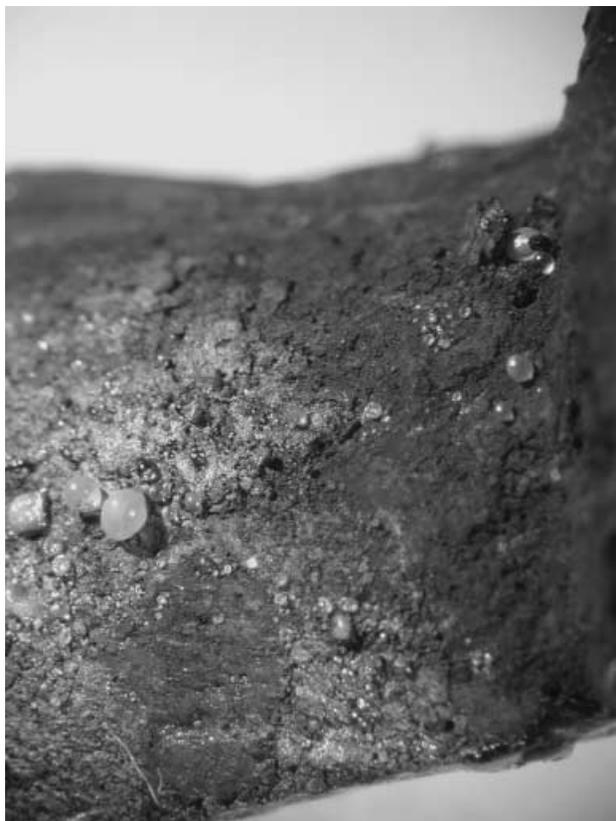
Figure 6. Rivet head from the *Hunley* exposed to the air for only a couple of days: Note initial indication of active corrosion in the form of the weeping phenomenon. (Copyright Friends of The Hunley Inc., 2000)

7. Weeping is the formation of drops of acidic liquid (often described as 'tears' or 'sweat') on the surface of excavated iron. The liquid in these drops has a low pH (1–3), a high concentration of Fe^{2+} and Cl^{-} ions, and relatively little Fe^{3+} ions. Weeping is attributed to the hygroscopic nature of iron chloride salts. Crystals of pale green $FeCl_2 \cdot 4H_2O$, for example, form when an iron (II) chloride solution dries rapidly. If these crystals are then exposed to a relative humidity above about 56%, the salt deliquesces and forms bubbles of liquids (Selwyn, 1999: 4).
