# Creating Priorities in a Building that Needs **Everything**

# Polk Hall – 1920s

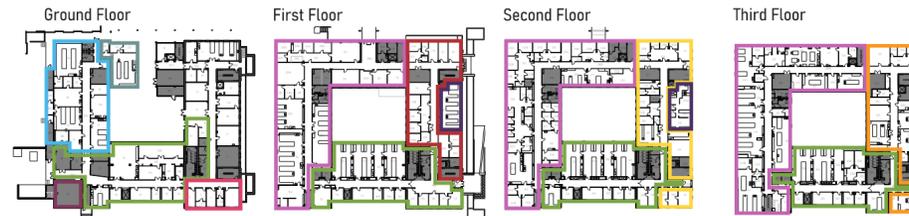
MECHANICAL AIR HANDLER UNIT ZONES

Inefficient mech zones

- 1. Ongoing envelope concerns**
  - significant roof and windows
- 2. Aging mechanical systems**
  - complicated layout with ten individual air handler units
  - lack of consistent controls and monitoring
  - very high energy use
- 3. Aging electrical systems**
  - electrical equipment (panels, feeders, etc) is beyond life expectancy and in need of replacement

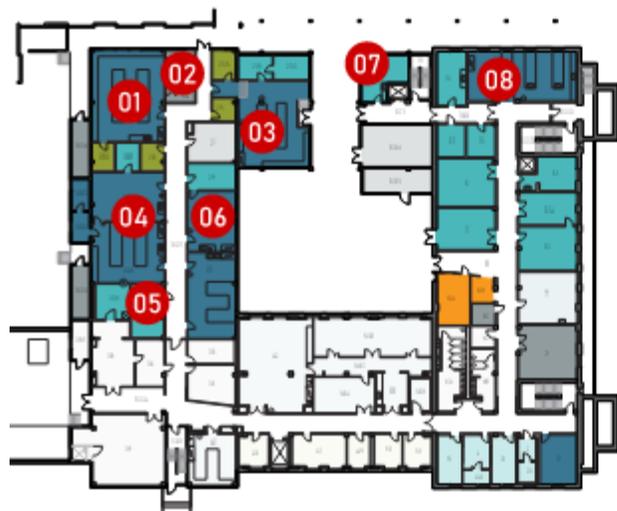
ground floor

○ ISB connection  
potential microscopy suite

- 01 Xu teaching lab - higher floor level
- 02 non-accessible restrooms, not required
- 03 teaching lab, stepped room
- 04 Doherty lab - requires dark room  
some moisture concerns
- 05 Large cold room - underutilized
- 06 29 - shared cell culture - problematic  
29A - Dept. centrifuge (Doherty + Xu)  
31 Sartor lab - needs cold room access
- 07 Doherty lab support - plumbing issues
- 08 original teaching - vacant, issues

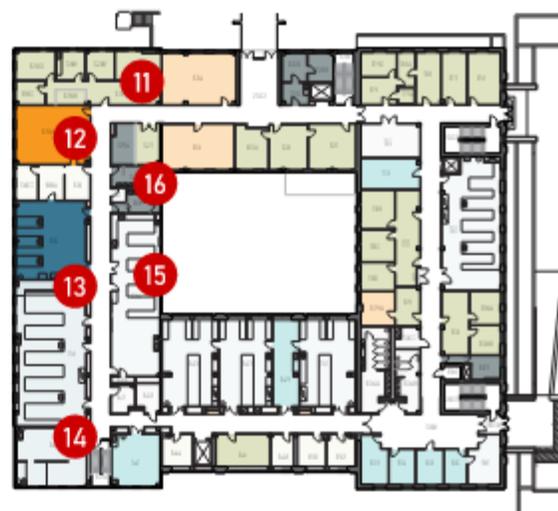
first floor

○ consider entry sequence  
would like increased transparency

- 11 Biochemistry office suite
- 12 Flexible teaching for 32-40 students  
no windows, some moisture concerns
- 13 Ascencio-Ibanez and Simpson labs  
active, large student engagement
- 14 Cell culture lab, underutilized
- 15 Plant Research shared lab  
interior windows, recent renovation, shared support
- 16 non-accessible restrooms, may not be required

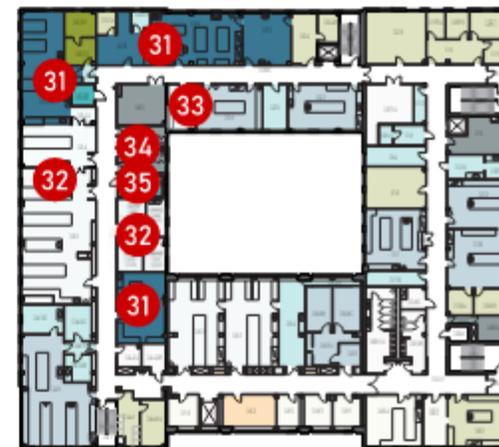
third floor

○ could support relocated ground floor labs  
prefer shared lab support spaces

- 31 Vacated research lab and lab support
- 32 Recently renovated lab and office space
- 33 Shared autoclave room
- 34 non-accessible restrooms, may not be required
- 35 Cold room, unused

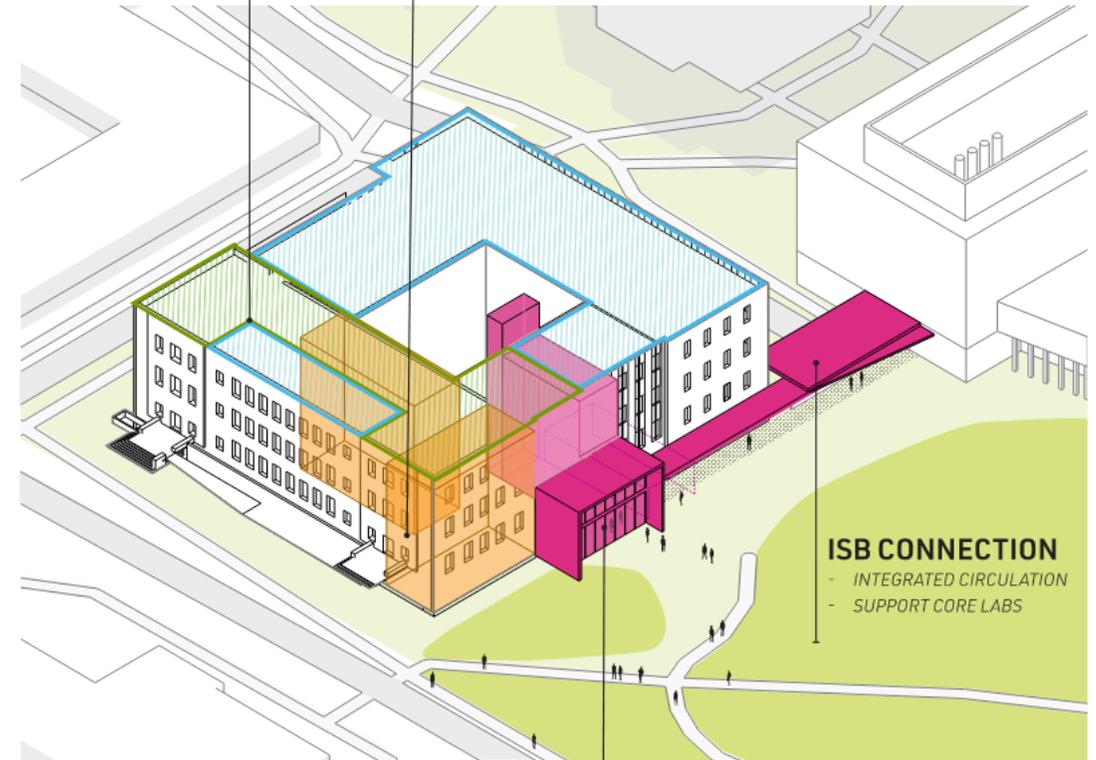
**ISB CONNECTION**  
 - INTEGRATED CIRCULATION  
 - SUPPORT CORE LABS

- Building Connection / Entry
- Lab
- Collaboration / Hub
- Office

**MAIN ENTRANCE**  
 - GROUND LEVEL  
 - BRICKYARD-FACING  
 - NEW VERTICAL CIRCULATION

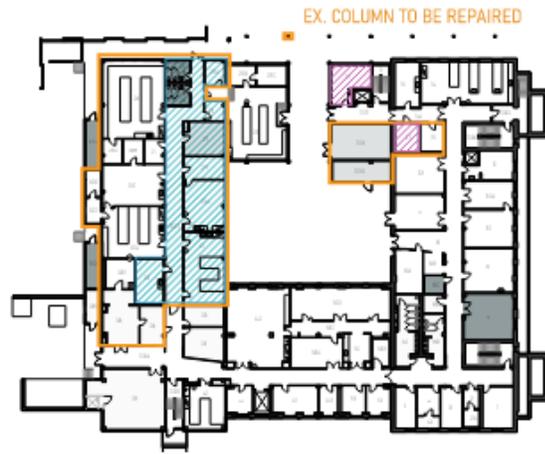
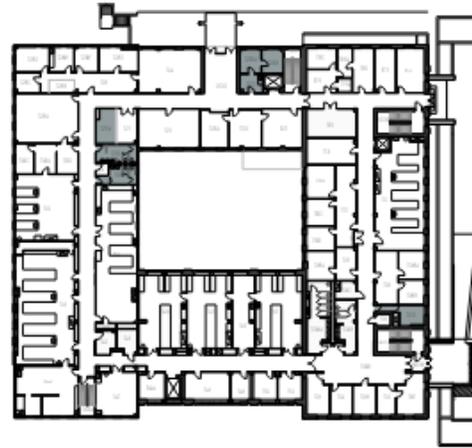
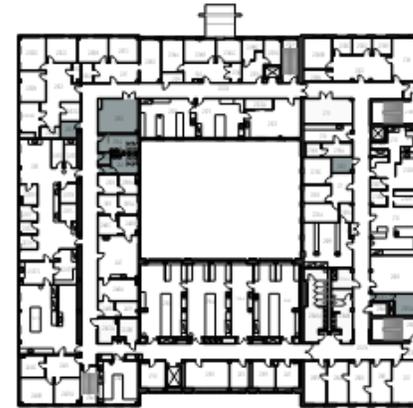
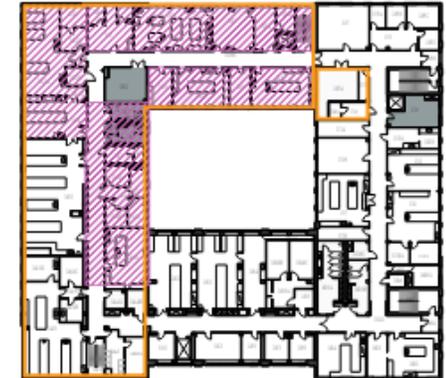
# PHASE 1

SCOPE 1

CRITICAL BUILDING SYSTEMS

SCOPE 2

THIRD FLOOR LAB SCOPE (FIRST)

SCOPE 3

GROUND FLOOR LAB SCOPE (FOLLOWING THIRD FLOOR)

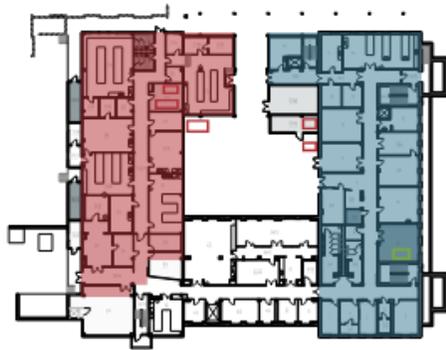
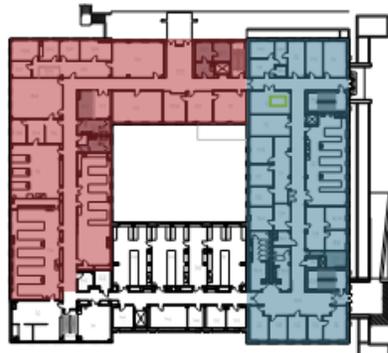
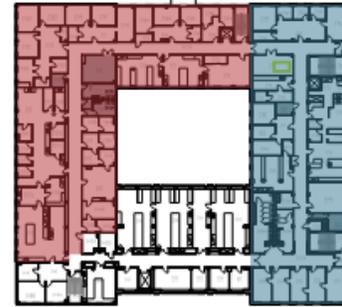
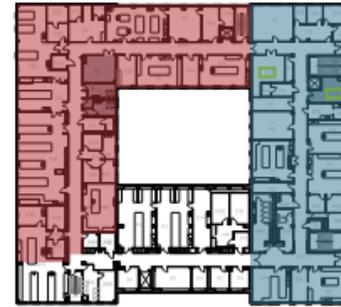
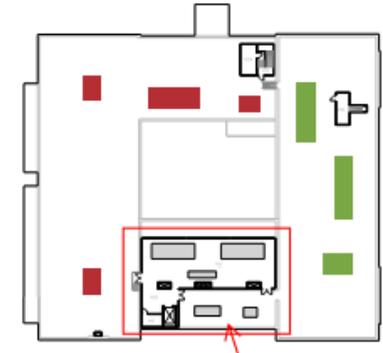
# Good/better/best scopes

This 2008 portion is "good"  
(this area can come out of the  
30,000SF number in the estimate)

01 NORTH/WEST WING BASE BID	\$20,887,000
	02 'GOOD' SCOPE (MINIMUM REQUIRED)	+ \$2,175,000
	03 'BETTER' SCOPE (MINIMUM REQUIRED)	+ \$3,750,000
	04 'BEST' SCOPE	+ \$11,990,500
